PROPERTY CONDITION ASSESSMENT

Building Inspection Services

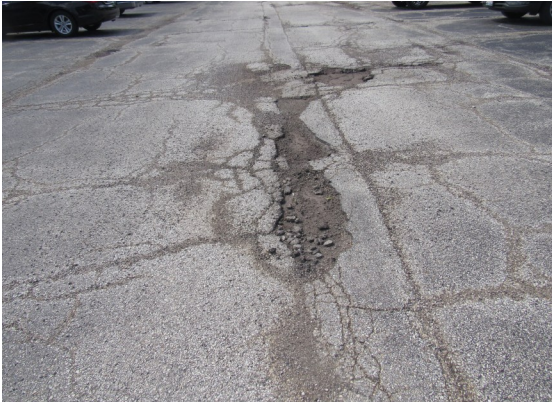
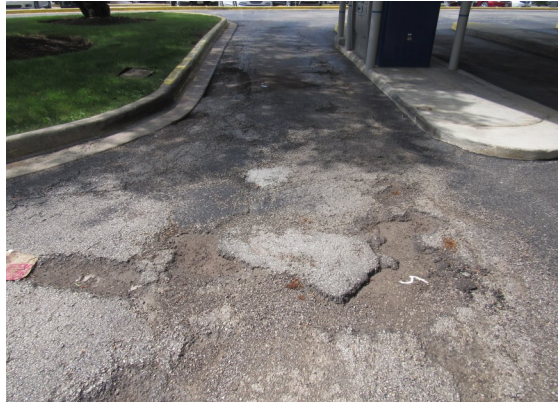
Visuals of parking lot deterioration, pot holes and general distress

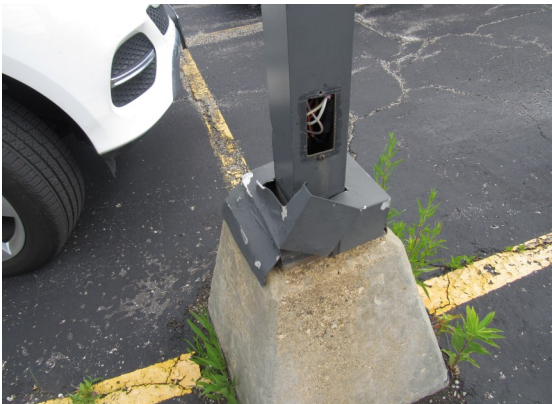
**Impact damaged and exposed wiring at
Parking lot overhead light**

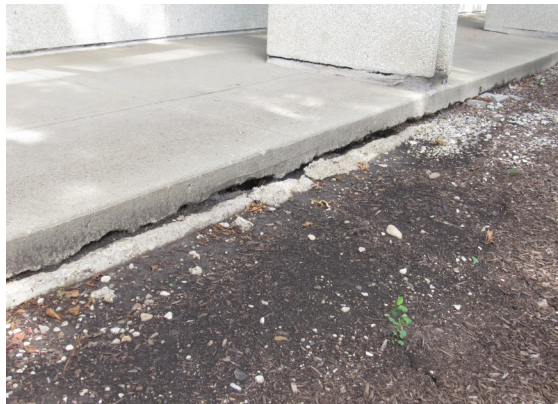
**Underpinning erosion at sidewalk
landing**

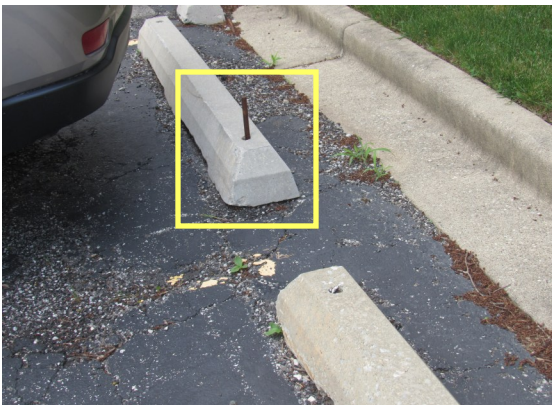
**Exposed re-bar at parking blocks is a safety
Hazard**

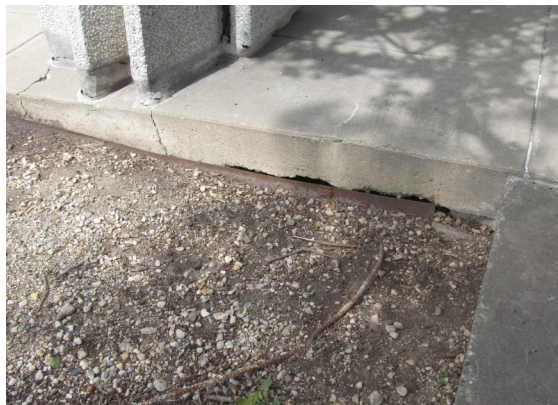
**Underpinned sidewalk from drainage
erosion**

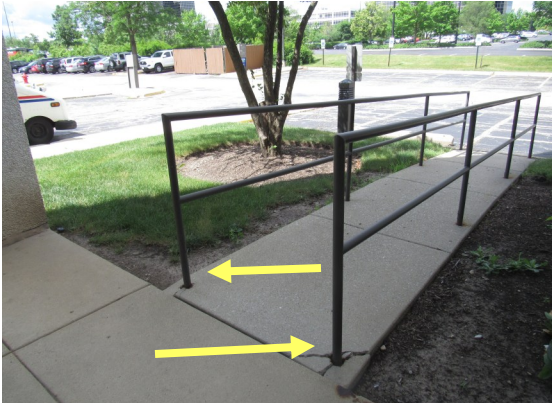
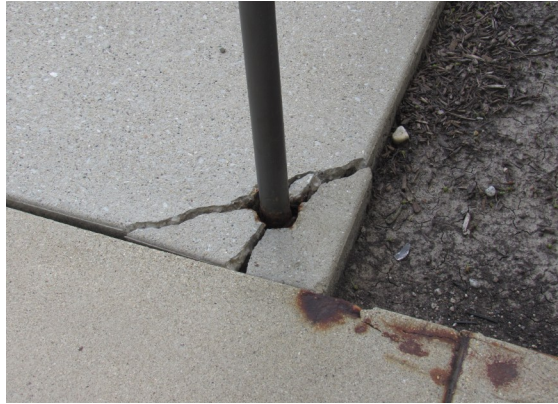
ADA ramp handrail support concrete cracked and damaged

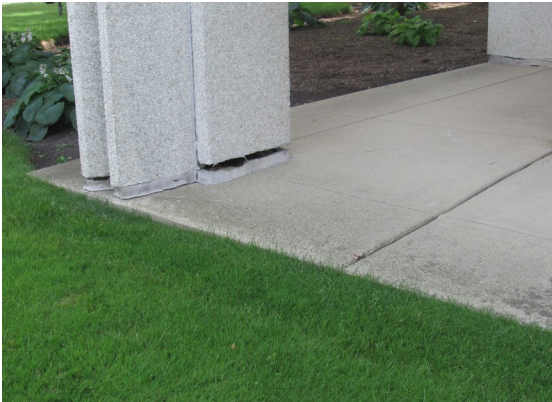
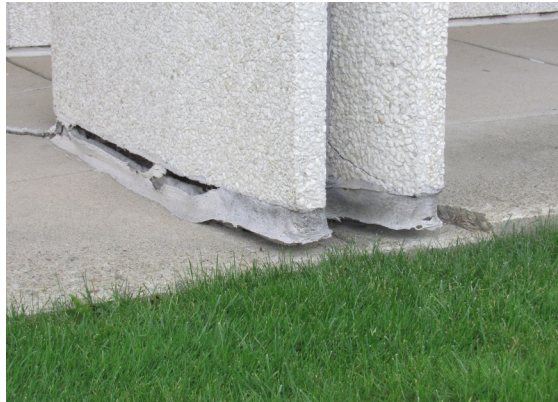
Failing concrete sidewalk/landing sunken and leaving masonry wall suspended

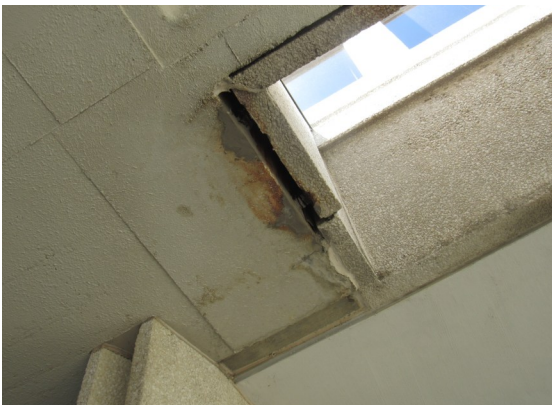
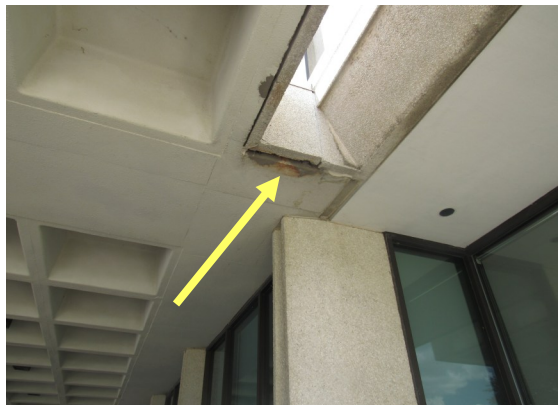
Water damaged behind concrete wall with past patching repairs noted

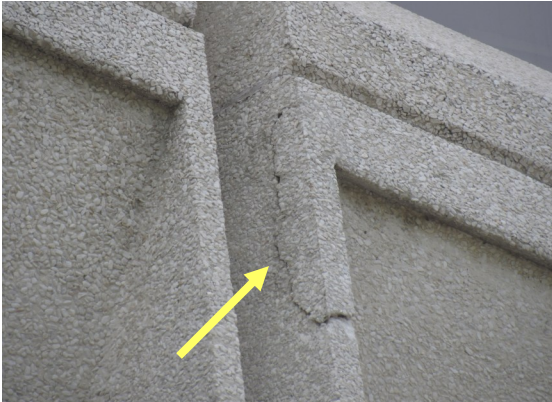
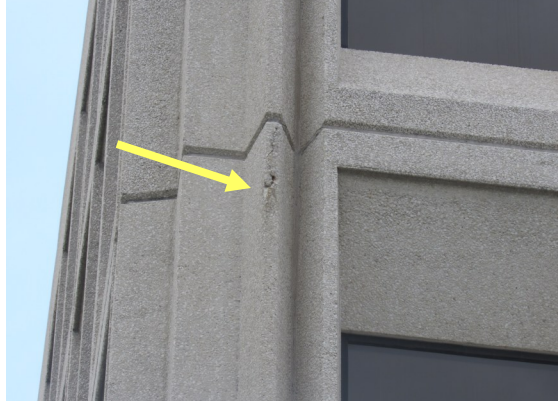
Cracking and spalling concrete pieces at exterior wall

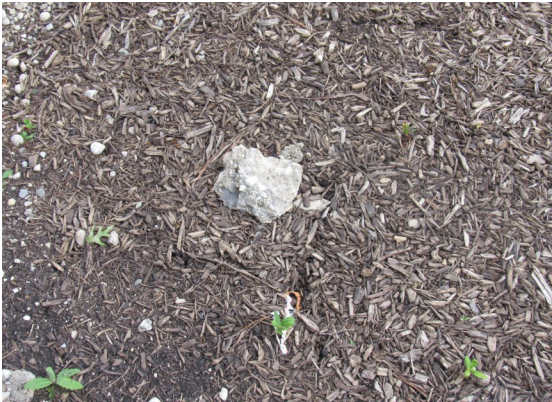
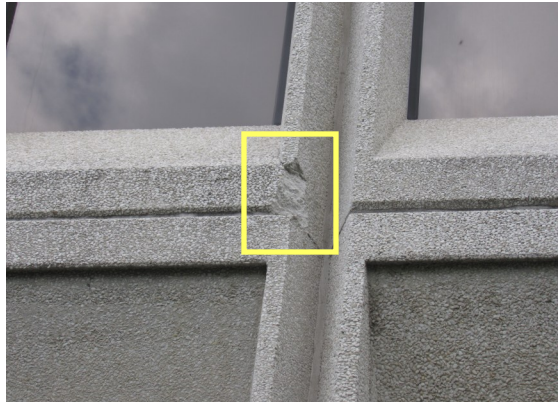
Fallen concrete pieces from exterior wall presents a life safety danger

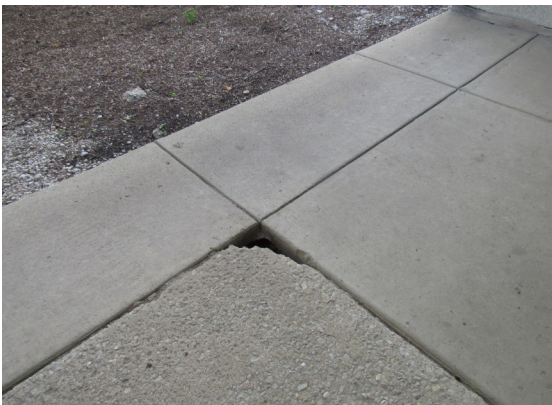
Void / hallow area under the deteriorated sidewalk along the side of the building near the subsurface generator

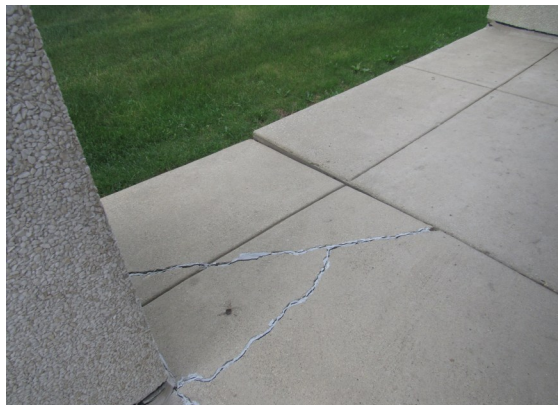
Sidewalk cracks and sunken suggests a potential compacting/stability issue

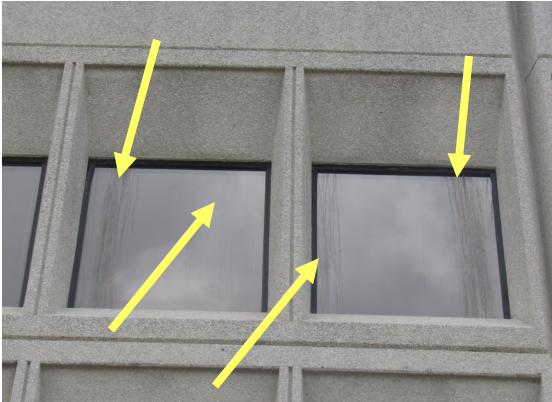
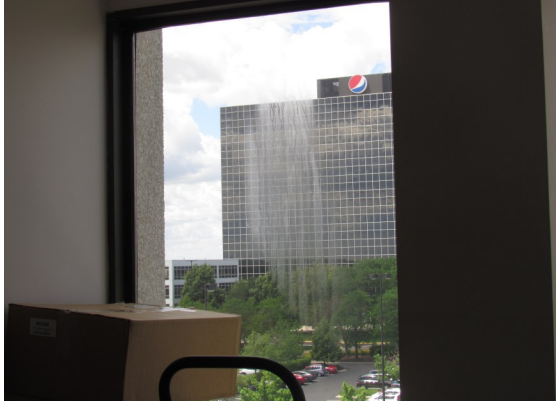
Example of fogged/compromised windows throughout the building on each floor

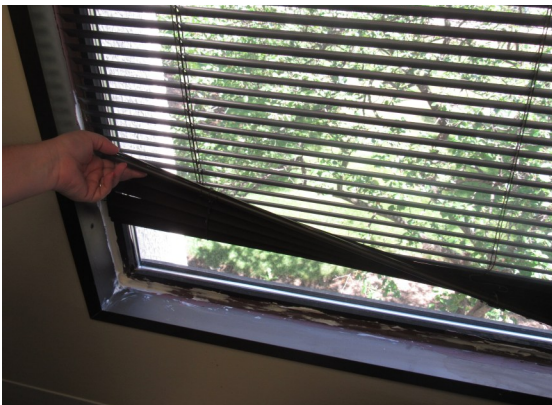
Caulk repairs for leaking windows

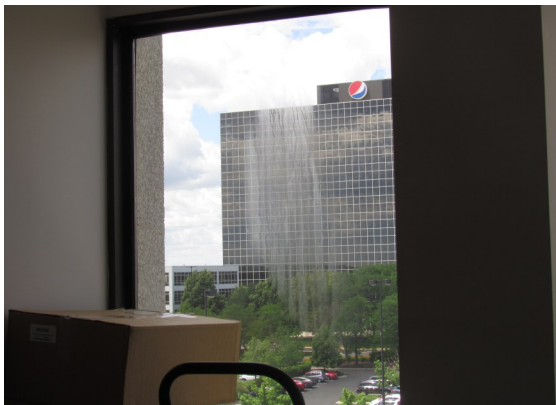
Fogged window example

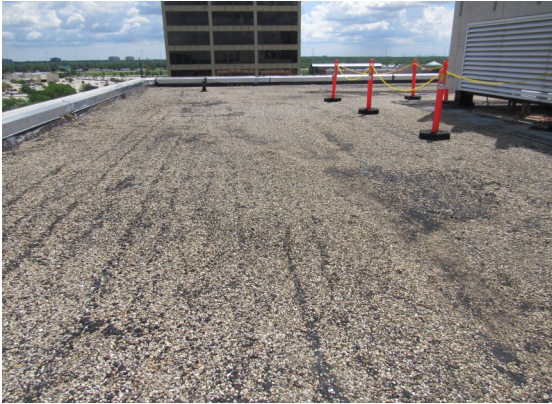
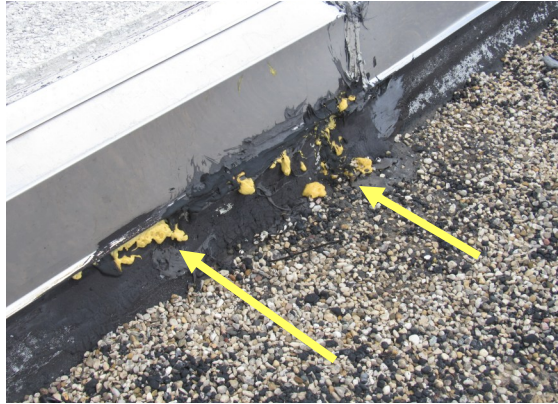
General view of Tar and Gravel built-up roof cover that is beyond its normal life of 20-25 year. Past amateur repairs noted

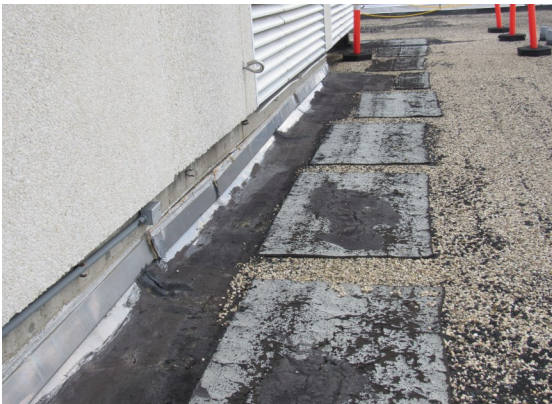
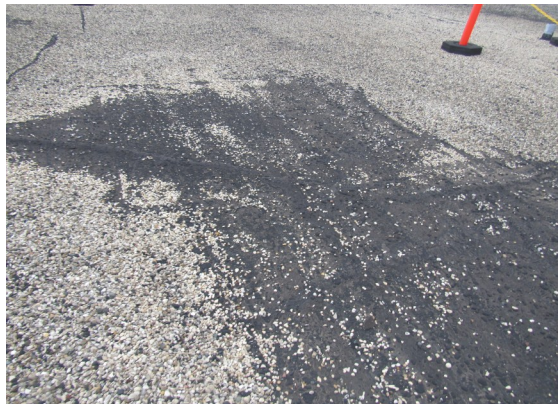
Heavy wear, cracking and exposed membrane

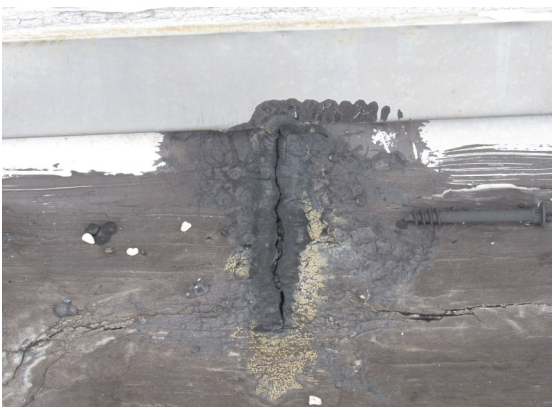
Past patching repairs re-cracking on roof

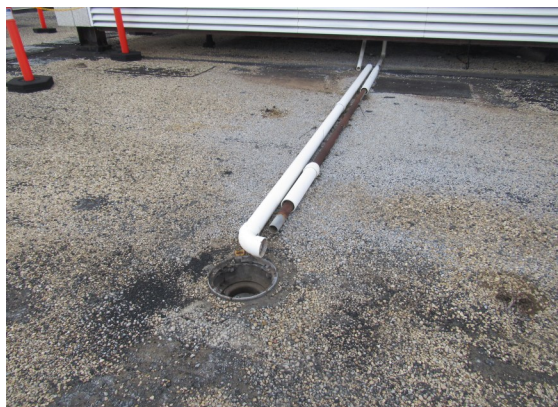
Missing downspout cage screens at roof

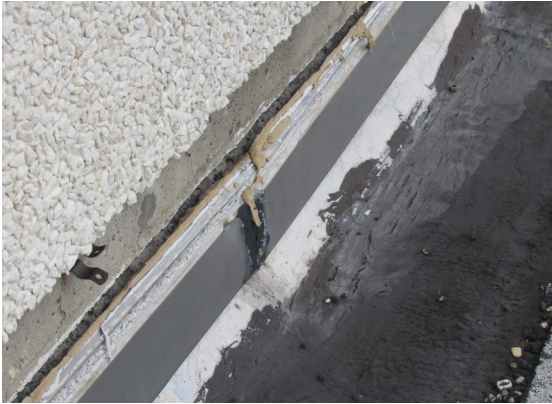
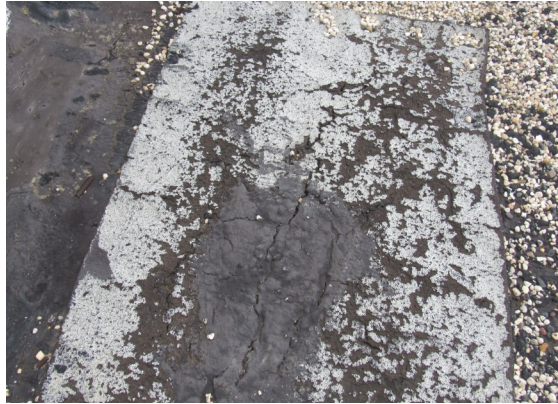
Roof flashing lift, gaps and age related cracking noted

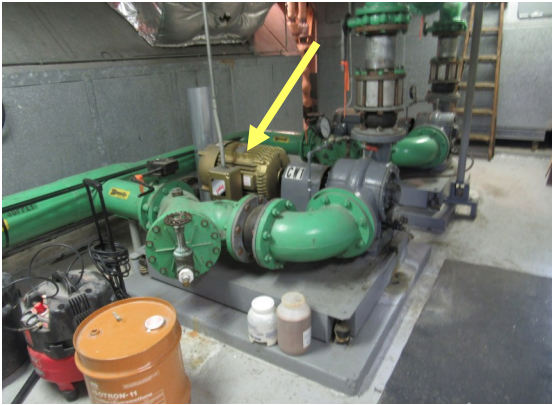
View of penthouse pump systems

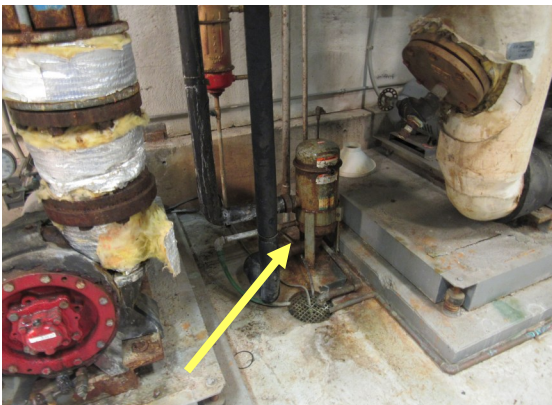
Water condensate and staining at refrigerant Plumbing in penthouse

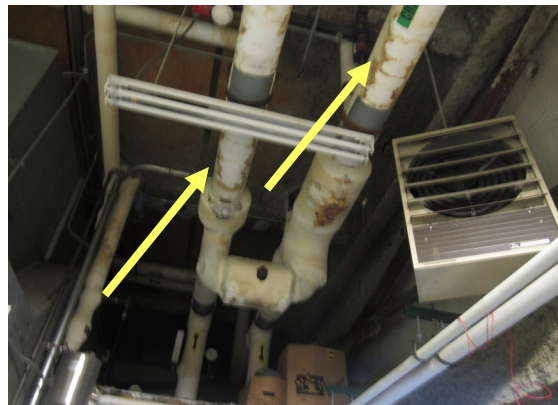
View of past water leak damage on pipe insulation of penthouse ceiling

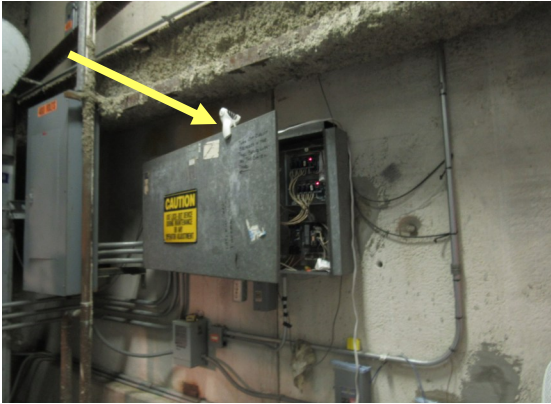
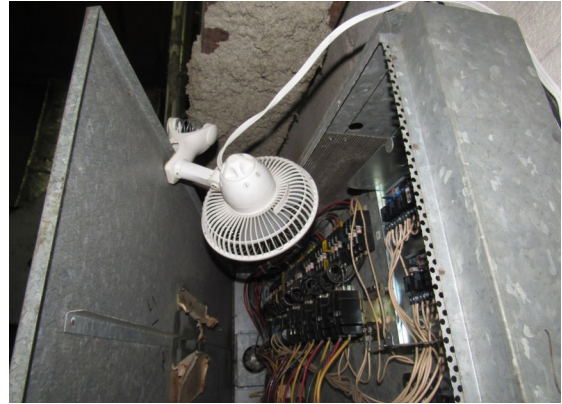
Exposed high voltage at open panels and non-standard fans setup to cool down electrical circuits—Safety risk noted

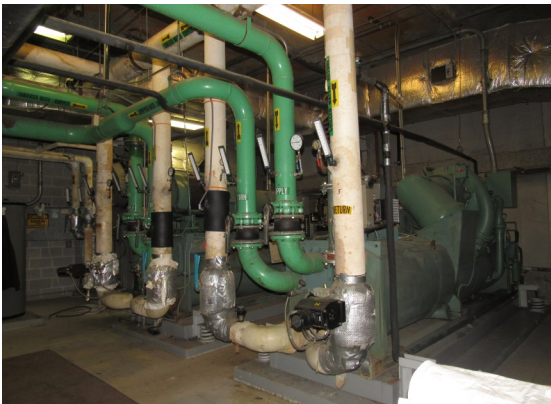
View of main Chiller system that appear to be 1978 original build—past repairs noted

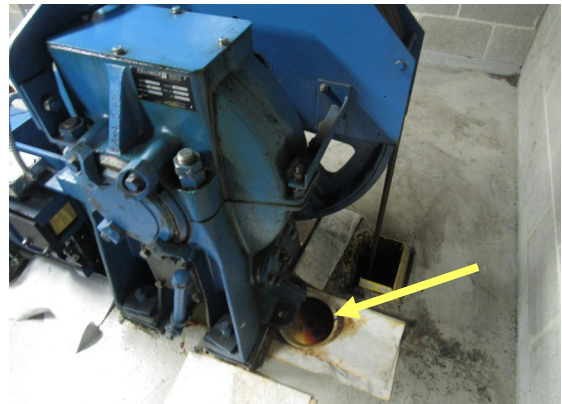
Oil collection at elevator mechanics

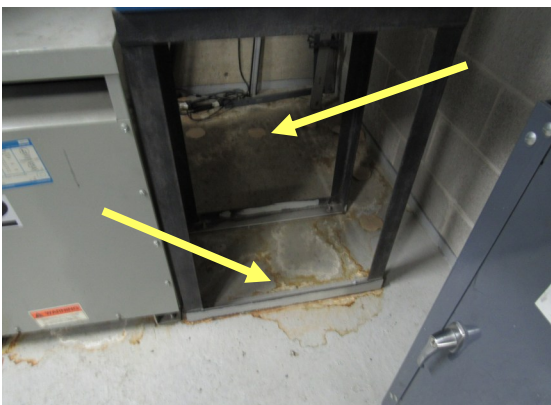
Past water stains in elevator room implies past roof cover or plumbing leak

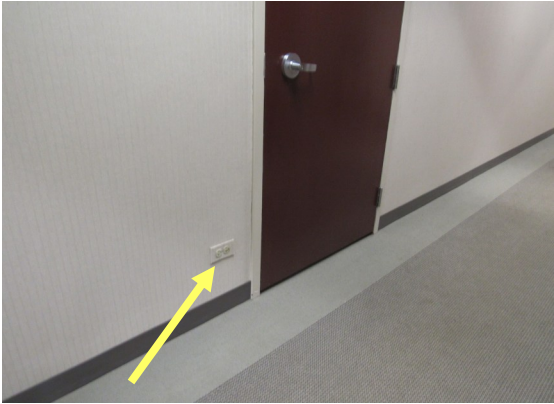
5th floor hallway outlet with broken ground

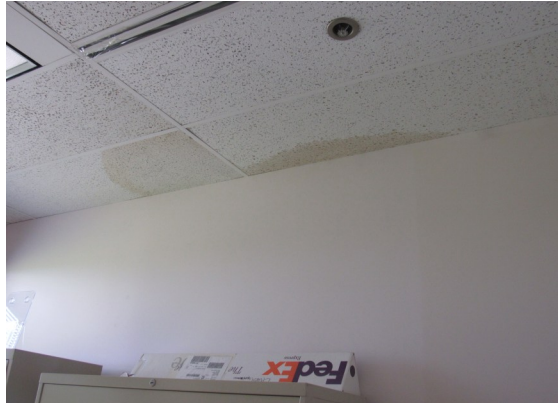
Multiple ceiling stains on 5th floor

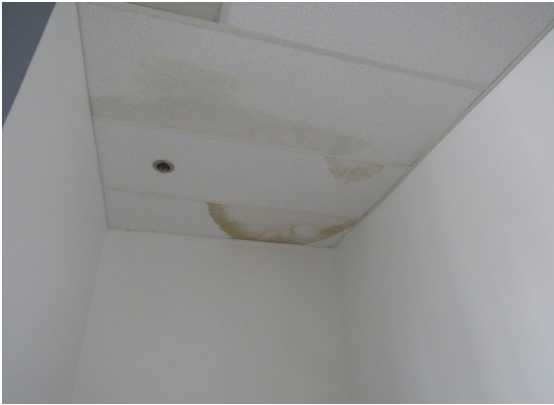
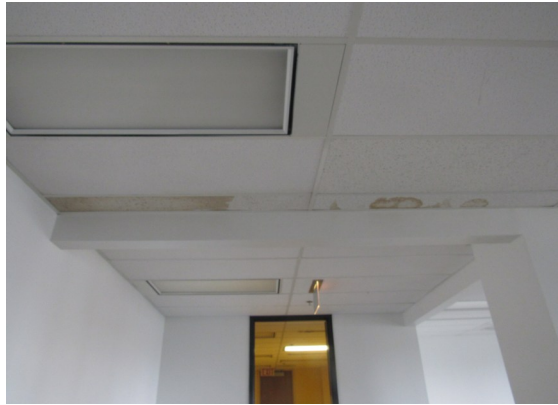
Ceiling stains throughout 5th floor suggest potential roof covering leaks/issues

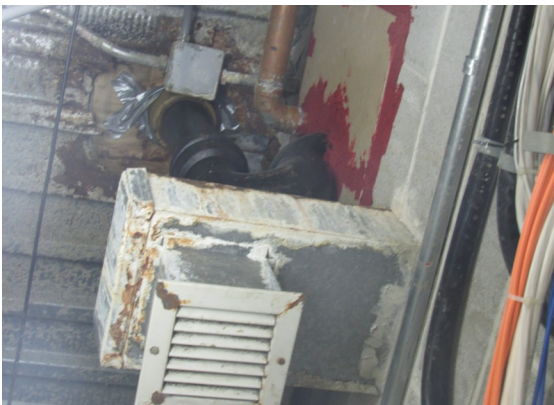
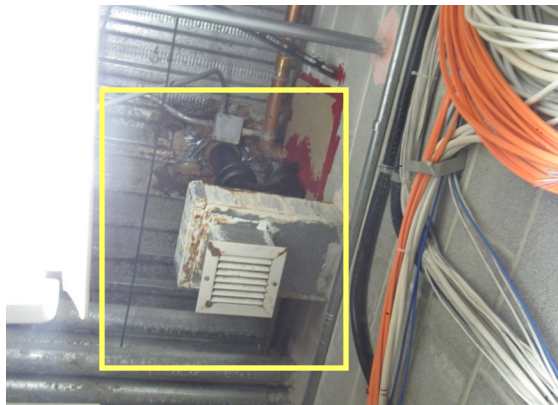
Water damage/stains at ceiling and air ducts in electrical closet of 5th floor

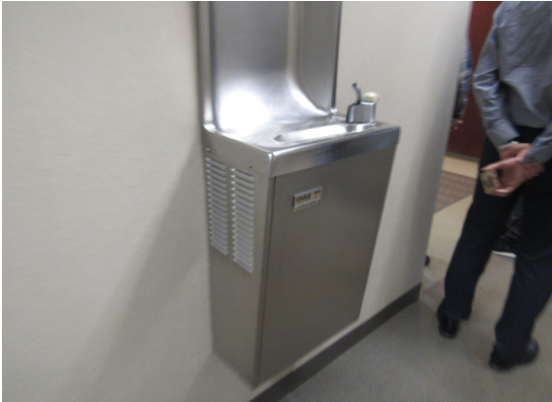
5th floor hallway drinking fountain not Operating properly

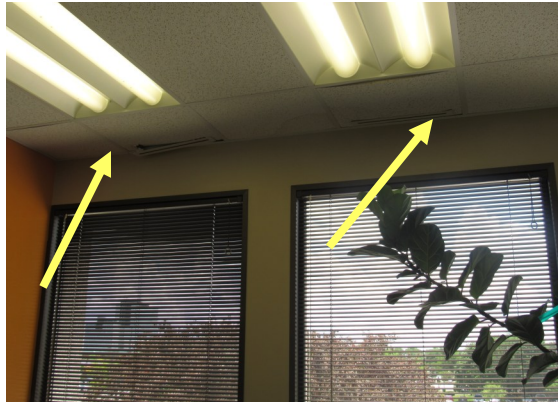
Suite 200 Ceiling, wall and window stains

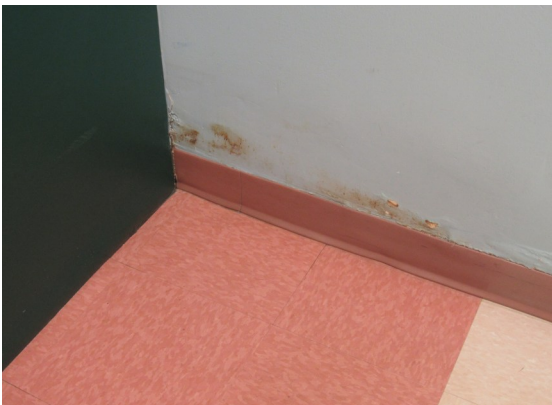
Deli area past water damage on wall

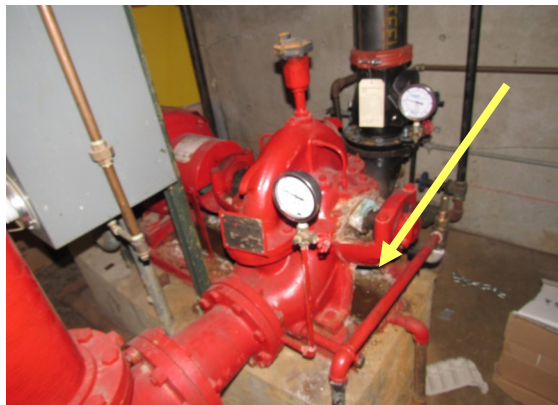
Basement fire pump water leak dripping

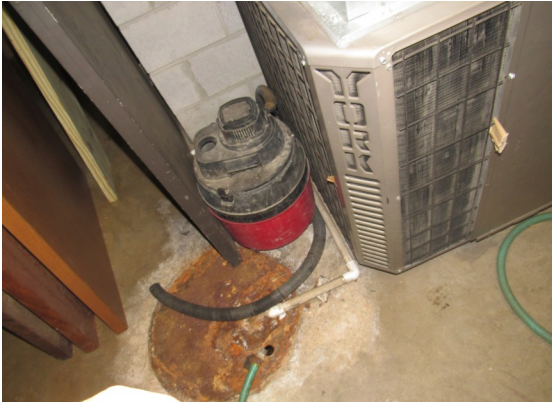
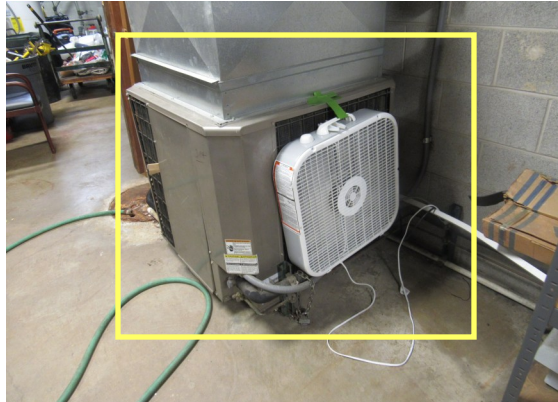
Exterior style A/C condensing unit installed in basement utility room with room fan modified for air flow, non-standard/unusual setup noted

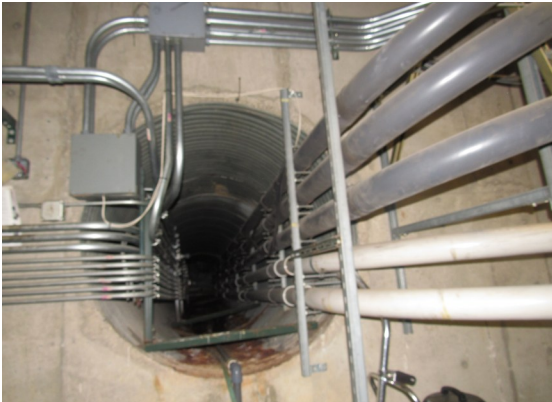
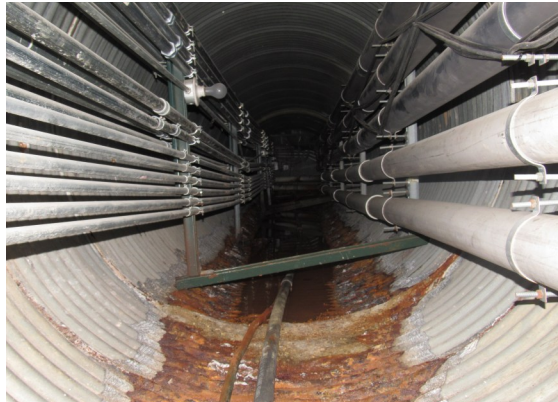
View of basement tunnel and standing water within
